AD NO. _____
TECOM PROJECT NO. 8-EI-495-BPF-001
REPORT NO. ATC-8199 (VOLUME II)
USAISR INSTITUTE REPORT LEAP 99-2

VOLUME II
FINAL REPORT
OF THE
LOWER EXTREMITY ASSESSMENT PROGRAM (LEAP 99-2)

U.S. ARMY INSTITUTE OF SURGICAL RESEARCH
EXTREMITY TRAUMA STUDY BRANCH
FORT SAM HOUSTON, TX 78234-6315

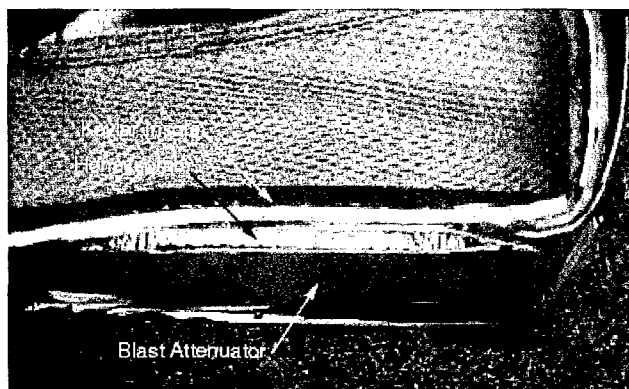
Figure 1: BB Cutaway

Various types and combinations of commercially available standard footwear and landmine protective footwear were evaluated and are listed in Table 1. The main objective of the study was to evaluate the level of protection of the Wellco® boots (study) compared to the standard combat boot (control). A small number of mines were tested against the BFR boot, Med-Eng boot, and improvised footwear to ascertain the potential effectiveness of these protective measures. The detailed descriptions of this footwear can be found in Volume 1 of this report. Figure 1 shows a cutaway of the Wellco® anti-mine footwear sole's construction showing the V-shaped blast attenuation plate and aluminum honeycomb. The pre- and post-blast weights of the boots as well as fragment weights were recorded. Photographs and descriptions of the footwear post-blast are contained in this volume in Appendix D, Detailed Footwear Damage Assessments. Two specimens were tested in a striding position against PMN mines wearing the BASIC P3I pants to ascertain their potential benefit in contralateral limb injury reduction.

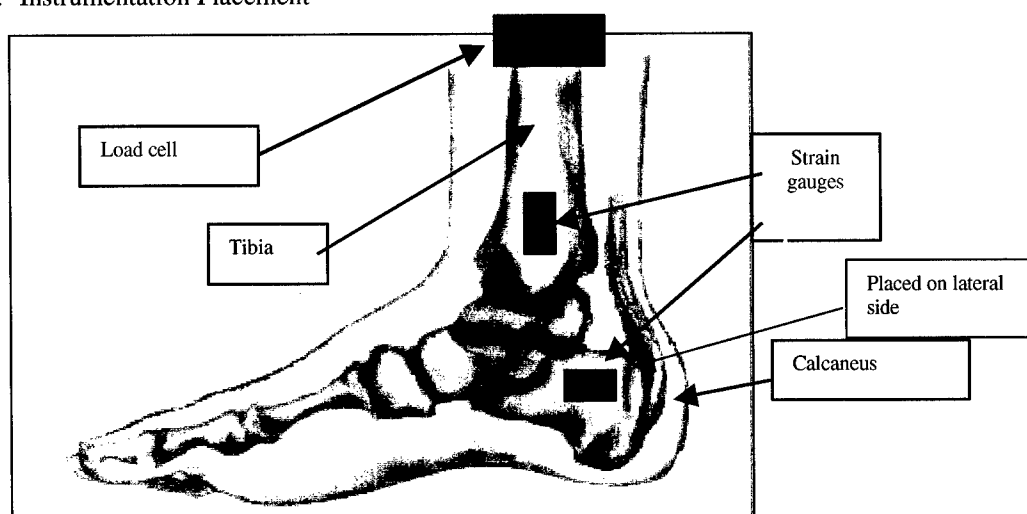
Figure 4: Instrumentation Placement

The initial PMN test was uninstrumented in order to evaluate the injury patterns, facilitate the placement, and access instrumentation survivability in subsequent PMN tests. Load cells were used to measure force. Utilizing previous models from automotive tests, a four-inch segment was removed from the proximal tibia using a surgical saw (Stryker, Santa Clara, CA). The load cell fixture was potted into place using polymethyl methacrylate (PMMA, Richards, Memphis, TN) and further secured by drilling transversely through the bone and using 2-mm diameter stainless steel wires at the proximal and distal ends of the load cell. A polyethylene spacer was used to maintain alignment and stability of the limb for transportation to the field test facility. Once on site, the spacer was replaced with the appropriate load cell. The strain gauge was placed on the distal medial aspect of the tibia and on the lateral surface of the calcaneus as shown in Figure 4. Several load cells were used during the course of the study. A uniaxial load cell was used in LEAP 99-1 to measure force, but it was determined that more axes were needed to properly understand the mechanism of injury and thus for LEAP 99-2 multi-axis load cells were used. All force and strain measurement equipment is fully described in Volume 1 of this report.

Fuji® Prescale Film: Pressure-sensitive film (Sensor Products, Inc., Forest Hills, NY) was used between the foot and the inner boot as well as between the inner and outer boots in an attempt to quantify force transmission properties of the footwear.

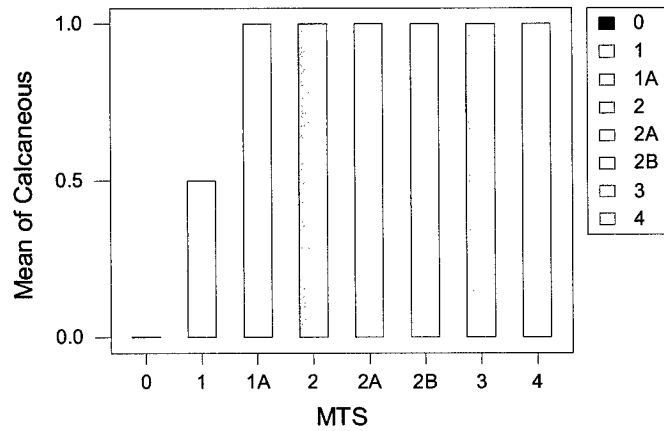
Figure 11: Calcaneus fracture by MTS.

Figure 11 shows the average value of calcaneus fractures that occurred with MTS for all mines. It is interesting to observe that a fracturing of the calcaneus is characteristic of the mine injury.

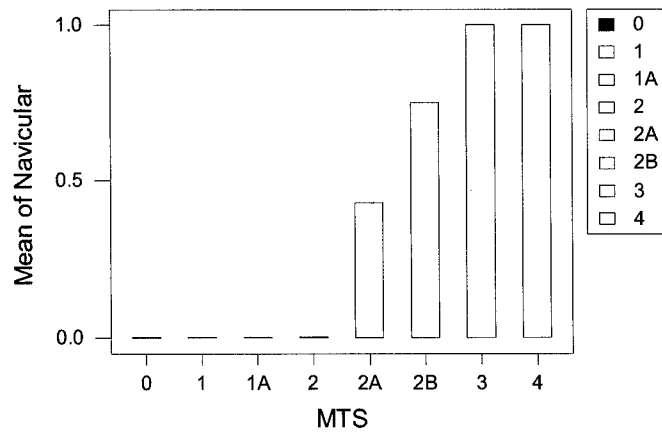
Figure 12: Navicular fracture by MTS.

Figure 12 shows the probability of navicular fracture occurrence that compared to the MTS. Fractures of the navicular were not observed for MTS less than 2A, and that a fracture of the navicular is characteristic of MTS of 3 or greater.

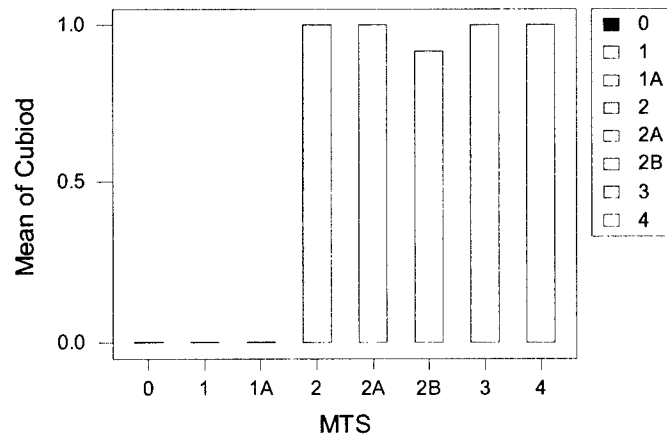
Figure 13: Cuboid fracture by MTS.

Figure 13 shows that a fracture of the cuboid is characteristic of the MTS of 2 or greater.

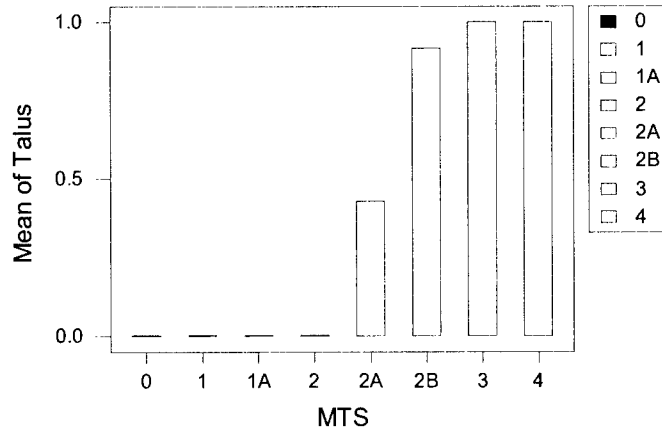
Figure 14: Talus Fracture by MTS.

Figure 14 shows that fracture of the talus follows the same trend as the navicular, with a talar fracture not occurring with a MTS less than 2A.

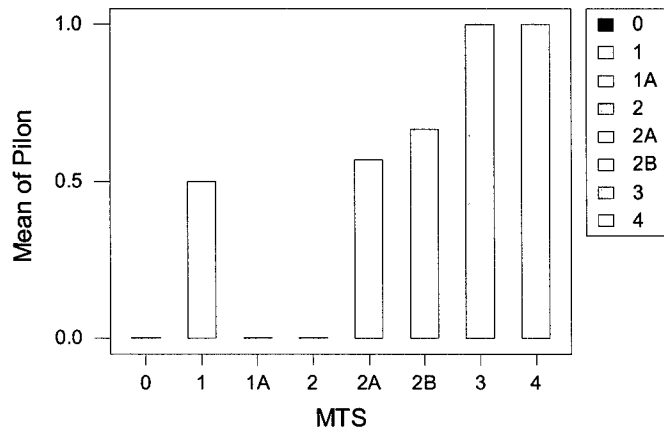
Figure 15: Pilon fracture by MTS.

Fracture of the pilon area with respect to the MTS is shown in figure 15. Significant pilon fractures occur with higher MTS.

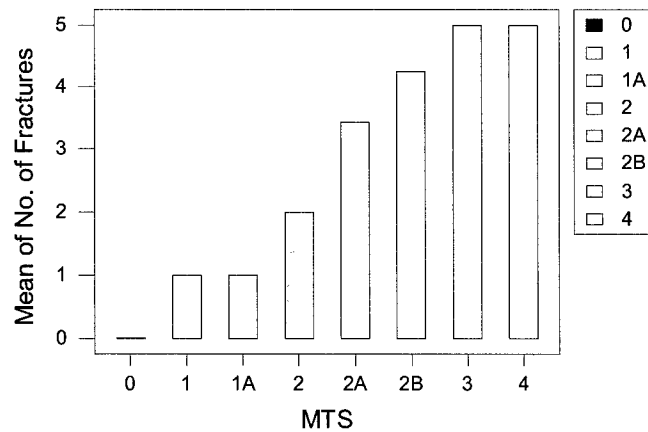
Figure 16: Number of fractures associated with MTS.

Figure 16 shows the number of fractures that generally are associated with a mine injury.

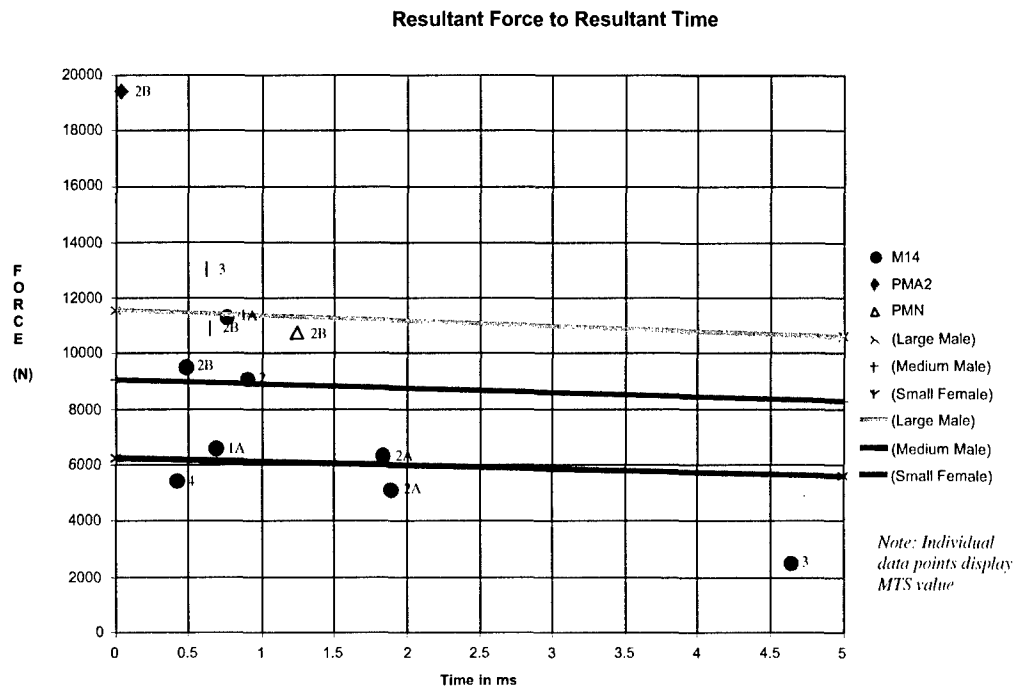
When resultant peak load data is plotted against time to peak load for the various MTS scores (*Figure: 17*) there does not appear to be a correlation. Superimposed on the same figure are injury predictive curves for long bone failure in axial loading of the lower limb derived from automotive crash testing (United States Army Aeromedical Research Laboratory, 1997). MTS values denoting severe injury fell below the low risk threshold curves invalidating the use of existing automotive crash test risk curves in predicting direct contact mine injury.

Figure 17: MTS to Femur Injury Threshold Curves (Hybrid III) (Mertz, 1993)

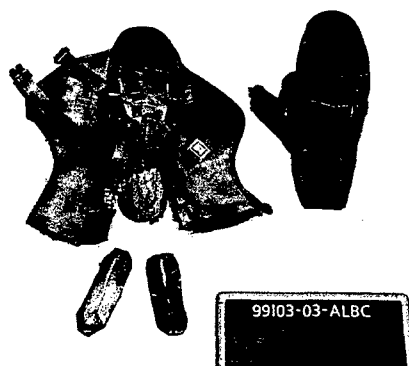
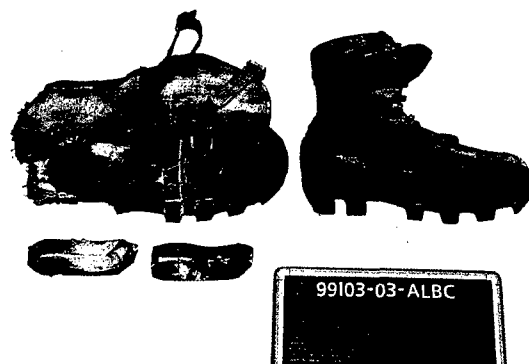
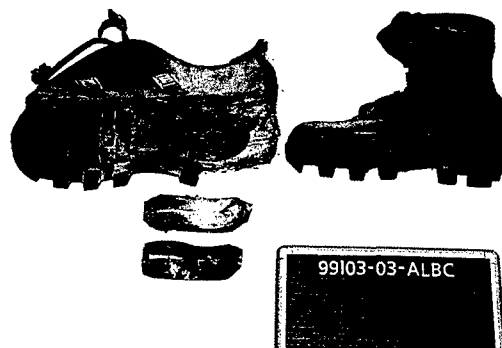
The overboot has had approximately 3 ½ inches of the heel portion of its sole completely destroyed. The blast deflector, attenuator, and attenuator plate have been completely separated from the overboot. The rear two-thirds of the blast deflector has been flattened and bent upward approximately 1 inch. The rear two-thirds of the attenuator has been completely compressed and bent upward 1 inch. The Kevlar insole is intact, and apparently undamaged. The cloth covering over the Kevlar insole has two longitudinal tears, one approximately 1 inch, the other 3 inches, both in the heel area. The overboot's Kevlar upper has been completely split down the Achilles seam and is separated from the sole over the entire heel area, but otherwise appears to be intact with no damage to the Kevlar material itself.

The blast boot is intact with the only apparent damage being a slight concavity of the heel area of the sole, and a longitudinal 1 ½-inch cut in the sole on the lateral one-half of the heel. It appears that there has been a significant internal compression/bending of the deflector/attenuator, but no other damage is noted.

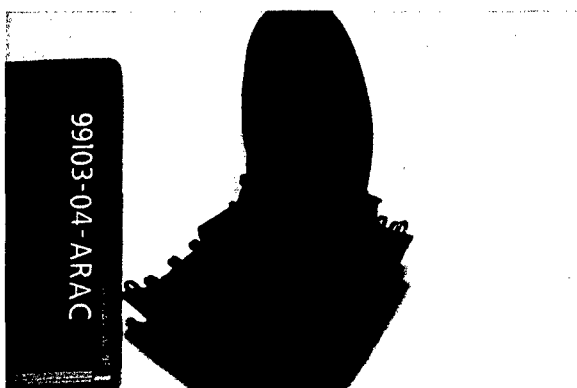
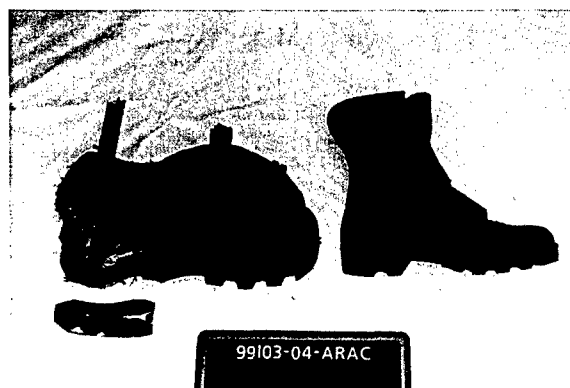
2 mm of this object exposed toward the foot. The canvas covering has been separated from the Kevlar insole by the blast, and shredded over the heel area. Both halves of the overboot's upper have been separated from the heel area of the sole, and split down the Achilles seam, but otherwise appear undamaged, and intact.

The sole and leather upper of the standard combat boot are intact and undamaged. Removal of the combat boot's cushion insole reveals two tears in the leather insole of the boot. One is a two-inch lateral tear approximately 1/2-inch from the rear of the heel with the other being a 3-inch longitudinal tear from mid-heel to mid-foot.

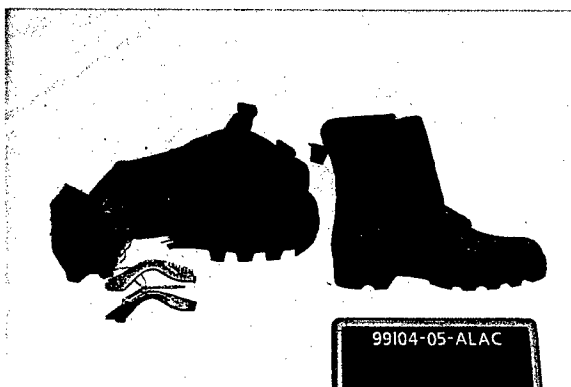
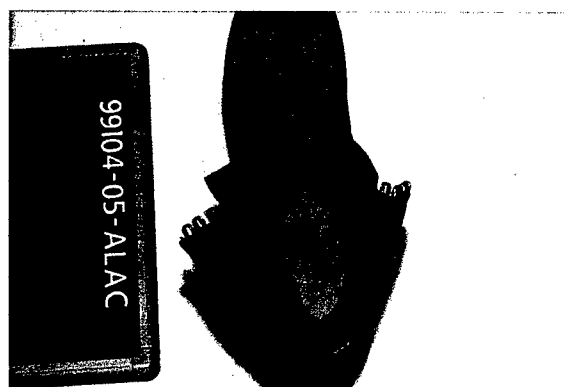
The rear 4 inches of the overboot's sole have been separated by the blast and remains partially attached to the canvas covering of the upper. The heel section of the sole was recovered in one large and two small fragments. There is a 2 ½-inch longitudinal tear in the midline of the sole at mid-foot. The blast deflector and attenuator have been completely separated from the overboot with the attenuator plate remaining affixed to the overboot. The mid-portion of the blast deflector has been flattened and bent upward approximately 1 ¼ inch. The rear 1 inch and the forward 1 ½ inches of the attenuator have sustained little or no compression. The mid-portion of the attenuator has been completely compressed and bent upward approximately 1 inch. The attenuator plate remains affixed to the overboot and has a slight indentation in its center. The Kevlar insole and its canvas covering appear to be intact and undamaged. The Kevlar upper remains attached to the insole, and remains joined along the Achilles seam.

The sole and leather upper of the combat boot appear to be intact and undamaged. Removal of the combat boot's cushion insole reveals a 1-inch lateral tear in the leather insole at mid-heel, which curves 90° and extends 3 inches longitudinally.

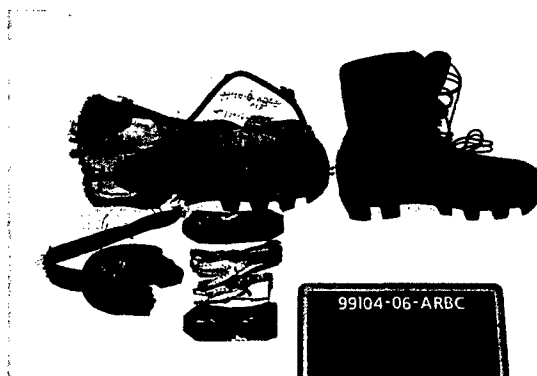
M14 Mine with blast boot/overboot combination.

The rear one-third of the overboot's sole has been removed by the blast. The majority of this portion of the sole, including the heel, was recovered in one piece. The blast deflector, attenuator, and attenuator plate were completely separated from the overboot. The front one-half of the blast deflector was flattened and bent upward approximately ½ inch. The front two-thirds of the attenuator has been completely compressed, with partial compression of the rear one-third. Several long strips have been shredded from the attenuator, and exhibit the same compression pattern. The attenuator plate has been bent slightly upward in the center. The Kevlar insole and its canvas covering appear to be intact and undamaged. The Kevlar upper has been separated from the sole from heel to mid-foot and has been separated down the Achilles seam, but otherwise it appears to be undamaged.

The sole of the blast boot has sustained a 3-inch longitudinal tear down the mid-line from mid-heel to mid-foot. There appears to be slight internal bending/compression of the blast deflector/attenuator resulting in a slight concavity of the sole at mid-heel. There has been a slight separation of the leather upper from the sole on both sides of the heel. The Kevlar insole, leather upper, and cushion insole are undamaged.

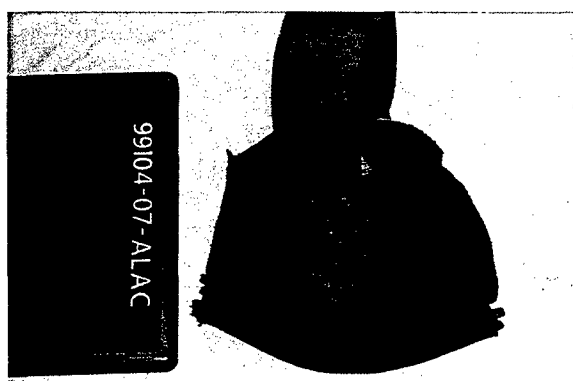
M14 Mine with combat boot/overboot combination.

The rear 3 inches of the overboot's sole has been removed by the blast. There is a 3-inch longitudinal tear down the midline of the sole from mid-heel to the front of the blast deflector. The blast deflector and attenuator have been completely separated from the overboot. The attenuator plate remains attached to the overboot. The rear one-half of the blast deflector has been flattened. There has been complete compression of the rear one-half of the attenuator, with the front half remaining uncompressed. There is a slight indentation in the attenuator plate at the center of the heel. The Kevlar insole and canvas covering remain attached to the overboot and appear to be undamaged. The Kevlar upper has been separated from the sole around the heel area on both sides and has been separated down the Achilles seam, but is otherwise undamaged. The sole and leather upper of the combat boot appeared to be undamaged. Removal of the boot's cushion insole reveals a 1½-inch lateral tear in the leather insole of the boot across the mid-point of the heel, and a 2-inch longitudinal tear at mid-heel.

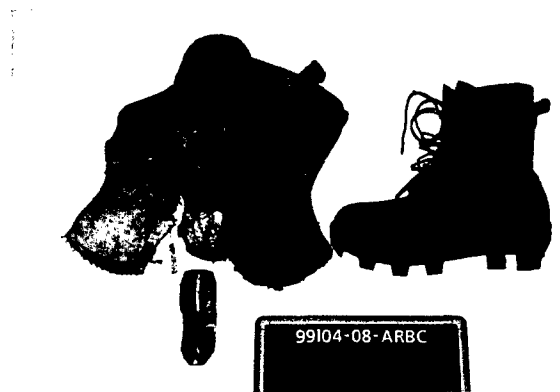
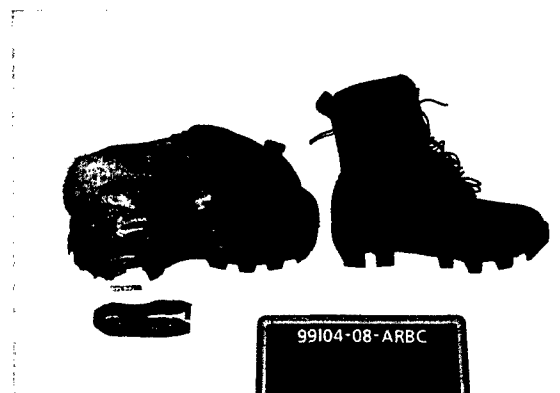
The rear 3 ½ inches of the overboot's sole have been blown off. The blast deflector has been completely separated from the overboot. The attenuator and attenuator plate remain attached to the overboot. The rear one-half of the blast deflector has been flattened and bent upward approximately ½ inch. The rear one-half of the attenuator has been completely flattened with the front half remaining relatively uncompressed. The attenuator plate has sustained no damage. The Kevlar insole and canvas covering are intact and appear to be undamaged. The Kevlar upper has been separated from the sole over the entire heel area. The lateral section of the Kevlar upper sustained a 1-inch vertical tear at mid-heel.

The sole and leather upper of the blast boot have sustained no obvious damage. There appears to be internal flattening/compression of the blast deflector/attenuator resulting in a slight concavity of the sole at mid-heel.

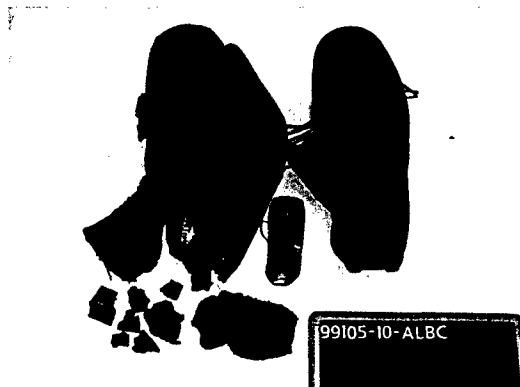
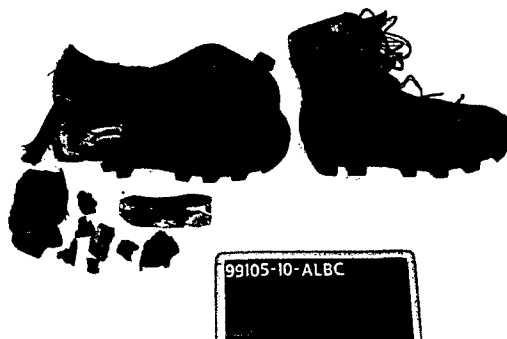
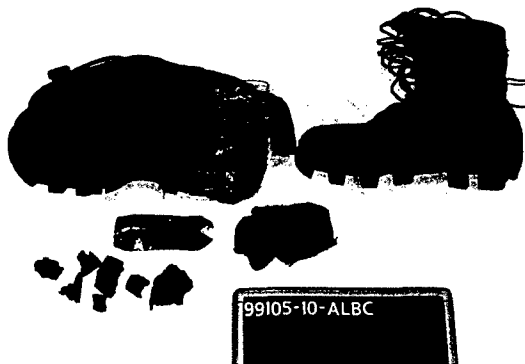
The rear 4 inches of the sole of the overboot has been blown away by the mine and recovered in several large pieces. The blast deflector has been completely separated from the overboot. The attenuator and attenuator plate remain affixed to the overboot. The rear two-thirds of the blast deflector have been flattened and bent upward approximately 1 inch. The rear two-thirds of the attenuator has been completely compressed with little or no compression of the forward one-third. The Kevlar insole and canvass covering appear to be intact and undamaged. The Kevlar upper has been separated from the sole approximately 4 inches on each side of the heel area, and has been separated down the Achilles seam, but the Kevlar material itself is undamaged.

The sole of the blast boot has sustained a 2 1/2-inch longitudinal tear on the medial portion of the heel area. There has been a slight separation of the leather upper from the sole on the medial portion of the heel. There also appears to be internal bending/compression of the blast deflector/attenuator forming a 3/4-inch concavity of the sole at the mid-point of the heel. The Kevlar and cushion insoles are undamaged.

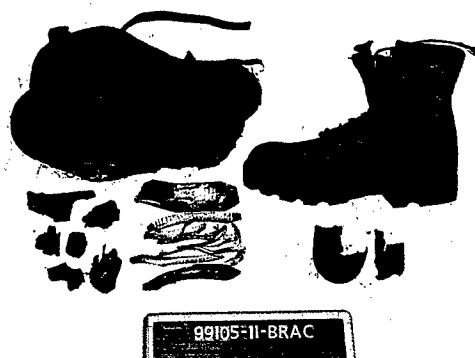
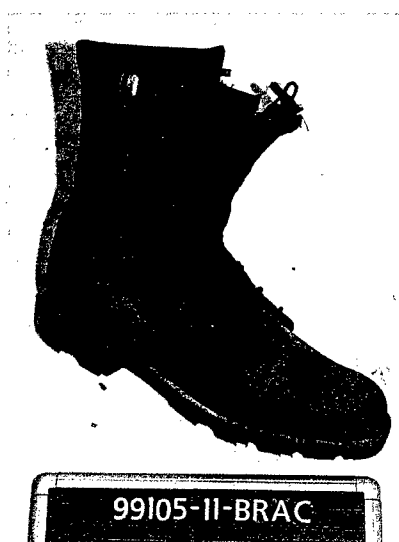
PMN Mine with combat boot/overboot combination.

The rear 4 inches of the medial and lateral sides of the overboot's heel have been removed by the mine, with a 1 inch x 2 inch section of the sole remaining along the mid-line of the heel. The blast deflector, attenuator, and attenuator plate were completely separated from the overboot. The majority of the deflector has been flattened, and bent upward approximately $\frac{1}{2}$ inch in its center. The attenuator has been completely compressed, shredded, and was recovered in several long strips. The center of the attenuator plate has been bent upward, and slightly twisted. The Kevlar insole remains attached to the overboot and appears to be undamaged. The rear 1 inch of its canvas covering has been separated and shredded. The Kevlar upper has been completely separated at the Achilles seam with the lateral portion being separated from the sole to the toe, and the medial portion being separated from the heel to mid-foot. However, the Kevlar material appears to be undamaged.

The sole of the combat boot appears to be undamaged. The leather upper has been separated from the sole of the combat boot at the arch for approximately 3 inches, and has sustained a 2-inch vertical tear at the arch perpendicular to a 5-inch horizontal tear from the arch to the fourth eyelet. There is a $1\frac{1}{2}$ inch vertical tear over the medial side of the heel, and the leather upper has been separated from the sole on the lateral side of the boot about 6 inches at mid foot. There is a tear in the leather upper from the heel extending vertically through the top of the upper, completely opening the boot. The rear 4 inches of the cushion insole have been blown away revealing the leather insole of the boot, which has been badly shredded by tears from heel to mid-foot.

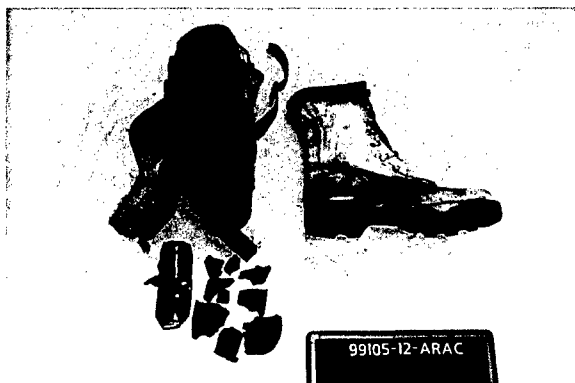
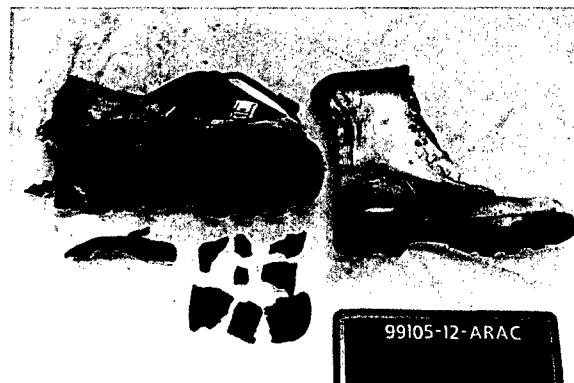
M14 Mine with combat boot/overboot combination.

The rear 4 inches of the overboot's sole have been completely removed by the mine, and recovered in eight large pieces. The blast deflector, attenuator, and attenuator plate have been completely separated from the overboot and remain attached to one another as a single unit. The rear two-thirds of the blast deflector/attenuator has been flattened/compressed, and bent upward approximately 1 inch with the front one-third remaining relatively undamaged. The Kevlar insole remains attached to the overboot, and appears to be undamaged. The Kevlar upper has been separated from the sole and insole around the entire heel area of the overboot. The Kevlar upper has been completely separated at the Achilles seam, but appears not to have sustained any damage to the Kevlar material itself.

The sole and leather upper of the combat boot are intact and undamaged. Removal of the combat boot's cushion sole reveals a 3 1/2-inch longitudinal tear and a 1-inch lateral tear at mid-heel of the boot's leather insole. There are small, superficial tears in the underside of the cushion insole, which correspond to the tears in the leather insole.

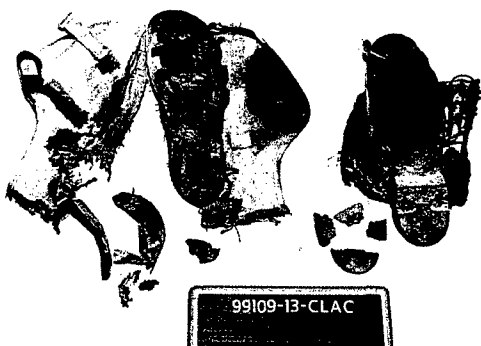
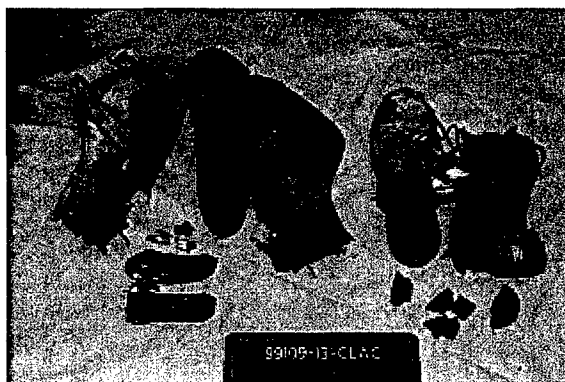
The overboot has sustained extensive damage with approximately 5 inches of the heel portion of the sole destroyed and missing. The blast deflector, attenuator, and attenuator plate have been completely separated from the sole. The rear two-thirds of the blast deflector have been flattened and bent upward 1 inch. The attenuator has been completely compressed and shredded with only half remaining attached to the attenuator plate. The attenuator plate has been bent upward and twisted. The Kevlar insole has sustained some damage to the center of the heel area. There is separation of the Kevlar layers with a one-inch diagonal tear in the top layers, but the insole remains attached to the overboot. The canvas covering of the Kevlar insole has been shredded and separated from the insole approximately 4 inches from the heel toward mid-foot. The lateral portion of the Kevlar upper has been completely separated from the sole and has a 2-inch vertical tear in the Kevlar material approximately 3 inches forward of the Achilles seam. The medial portion of the Kevlar upper has been separated from the sole from heel to toe, and has been torn and shredded in an area approximately 3 inches x 3 inches on the medial portion of the heel. Both halves of the Kevlar upper have been completely separated at the Achilles seam.

The sole of the combat boot is intact with the only damage being a 3-inch lateral cut in the heel. The leather upper has been completely separated from the sole from heel to mid-foot. Four vertical tears have shredded the leather upper, each approximately 6 inches in length. The heel area of the leather insole has been removed by the blast and there are two 3-inch longitudinal tears in the leather insole at mid-foot.

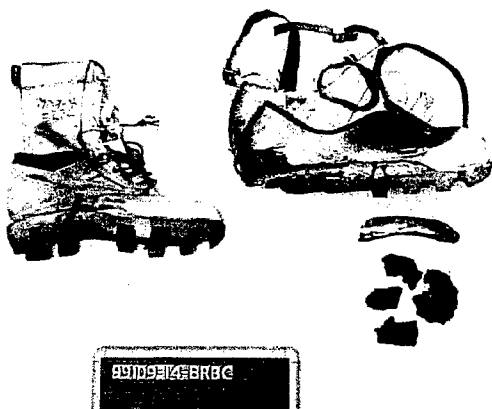
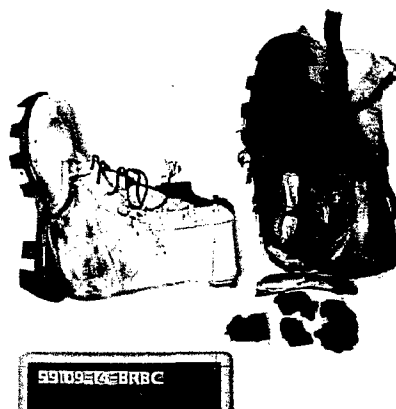
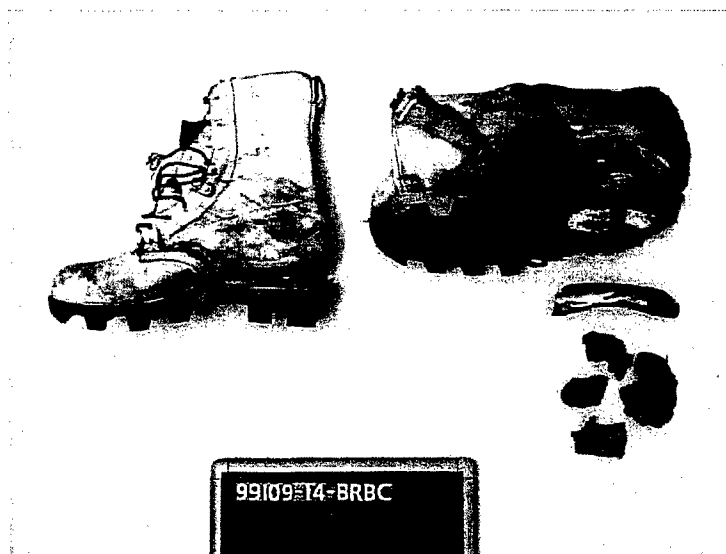
PMN Mine with blast boot/overboot combination.

The rear 4 inches of the medial and lateral sides of the overboot's heel have been removed by the blast, leaving a 1 inch x 1 ½ inch section of the sole intact at the mid-point of the heel. The blast deflector has been completely separated from the overboot and has been flattened over its rear two-thirds and bent upward approximately ½ inch in its center. The attenuator and attenuator plate remain attached to the overboot, with the attenuator being completely compressed for the majority of its length. Three strands have been shredded from the medial side of the attenuator, but remain attached to the overboot. The Kevlar insole remains attached to the overboot, and appears to be undamaged. The lateral half of the Kevlar upper has been separated from the sole from heel to toe, and the rear 5 inches of the medial half have been separated from the sole. The two sides of the Kevlar upper have been completely separated at the Achilles seam, but appear to not have sustained any damage to the Kevlar material itself.

The sole of the blast boot appears to be undamaged, but has been separated from the leather upper from the rear of the heel to the arch medially approximately 6 inches. The blast deflector, attenuator, and attenuator plate remain attached to the sole of the boot, with the medial portion of the attenuator plate and attenuator exposed. There has been upward bending/compression of the center portion of the blast deflector/attenuator, and the sole exhibits a ½-inch concavity at mid-heel. The leather upper has been torn on the medial side from the first eyelet down the seam to the arch. There is also a tear in the lateral side of the leather upper extending 4 inches horizontally from the Achilles seam to the fifth eyelet, and then vertically 1-½ inch. There appears to be no damage to the Kevlar insole or the cushion insole.

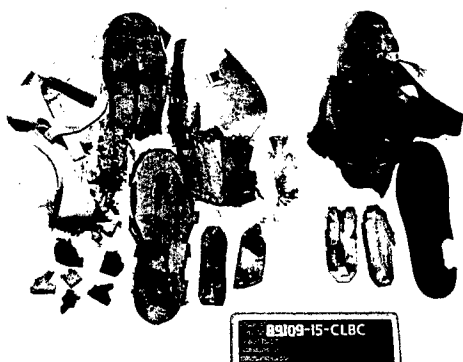
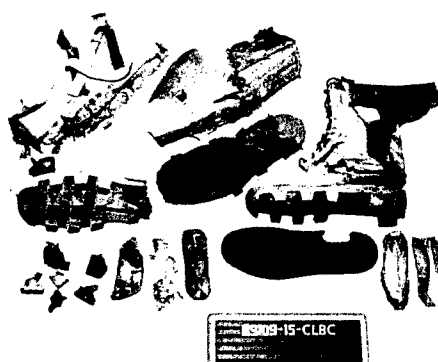
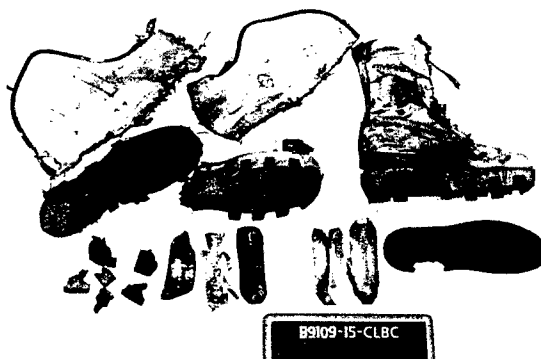
PMA-2 mine with blast boot/overboot combination.

The rear 5 inches of the overboot's sole has been removed by the blast. The components of the overboot have been completely separated by the blast. The blast deflector has been flattened down the rear one-quarter of its length, and bent upward approximately 1 inch at mid-heel. There is a 1-1/2-inch split down the mid-line of the blast deflector at mid-heel. The attenuator has been completely compressed with its medial half missing, and some small shredded fragments being recovered. The attenuator plate has been separated from the Kevlar insole and is badly deformed. The Kevlar insole has been separated from the overboot and is undamaged. The rear 2 inches of its canvas covering is missing and there is a 2-inch longitudinal tear in the cloth at mid-heel. Both the lateral and medial sections of the Kevlar upper have been completely separated from the overboot, with only the toe portion remaining attached to the sole. The medial and lateral portions have also been completely separated at the Achilles seam. The lateral portion of the upper appears to have sustained no damage to the Kevlar material itself. The medial portion of the upper has sustained a 2-inch vertical tear with shredding of the Kevlar material at a point 3 inches forward of the Achilles seam. No other damage to the Kevlar material is noted.

The sole of the blast boot has sustained a 3-inch curved tear from the rear of the heel to the medial side. The forward medial heel lug is missing. The leather upper has been completely separated from the sole from heel to the mid-foot. The blast deflector, attenuator, and attenuator plate have been completely separated from the blast boot. The forward two-thirds of the blast deflector has been flattened and bent upward approximately 1 inch. The attenuator has been completely flattened down the majority of its length and remains attached to the attenuator plate, which is slightly bent upward. The lateral side of the leather upper has been badly shredded by one long vertical tear from the heel through the top of the upper, and a 3-inch vertical tear from mid-foot to the third eyelet. There is also a diagonal tear in leather upper from the first eyelet to the fourth eyelet on the lateral side. The medial side of the leather upper has a 4-inch diagonal tear from the first eyelet to the arch. There is also a 4-inch vertical tear along the rear of the heel. The Kevlar insole remains attached to the blast boot, is intact, and has no apparent damage. The cushion insole has been torn and shredded across the mid-heel area.

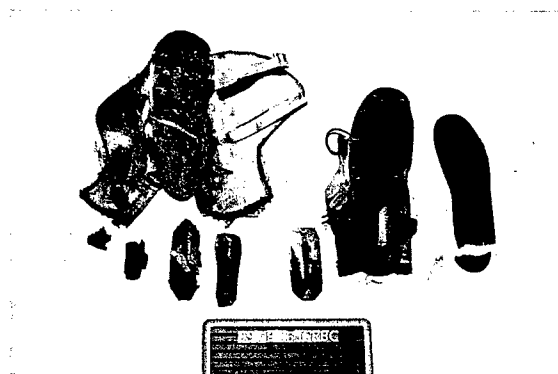
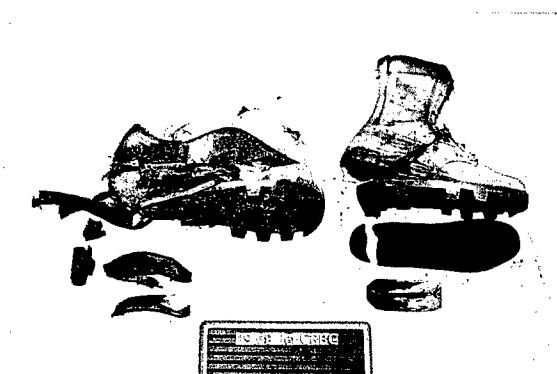
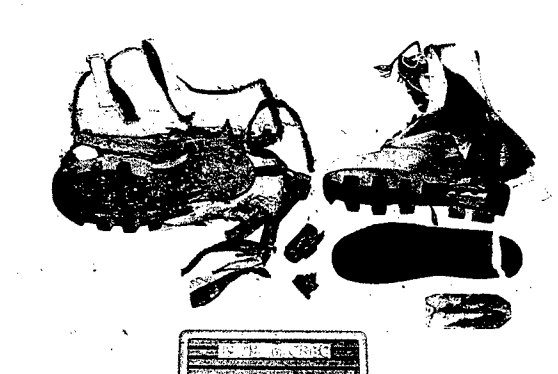
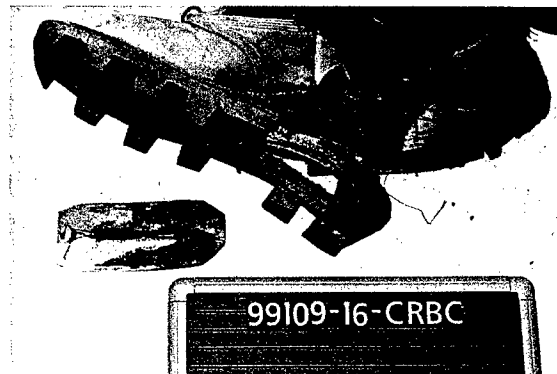
PMA-2 Mine with Blast boot/overboot combination.

The rear 4 inches of the overboot sole has been removed by the blast. There are two 2-inch longitudinal tears in the sole at mid-foot. The blast deflector, attenuator, and attenuator plate have been separated from the overboot. The rear one-quarter of the blast deflector has been badly flattened with a 2-inch longitudinal split in the metal down the mid-line at mid-heel. The rear one-half of the blast deflector has been bent upward approximately 1-½ inches. The rear one-half of the attenuator is missing with the remaining portion being completely compressed and remaining attached to the attenuator plate. The Kevlar insole remains attached to the overboot and appears to have a 1-inch lateral tear in the Kevlar material at mid-heel. The medial portion of the Kevlar upper has been completely separated from the overboot, but appears not to have incurred any damage to the Kevlar material itself. The lateral portion of the Kevlar upper remains attached to the overboot, and has been separated from the sole from heel to mid foot, and has a 1-inch vertical tear with shredding, at a point 4 inches forward of the Achilles seam where the upper attaches to the sole.

The sole of the blast boot is badly damaged with a 1-½ inch x 2-½ inch section of the medial portion of the heel missing. There are also two 1-inch diagonal tears at the rear of the heel. The blast deflector has been completely separated from the blast boot, and is almost completely flattened, and bent upward approximately ½ inch at mid-heel. The attenuator and attenuator plate remain attached to the blast boot with the attenuator completely compressed. The leather upper of the blast boot has been completely separated from the sole, from heel to mid-foot. It is also badly shredded on the medial side by a 9-inch vertical tear, from the sole to the padded collar of the upper, and a diagonal tear from the first eyelet to the fourth eyelet. A 5-inch vertical tear has shredded the lateral side of the leather upper, from mid-foot to the fifth eyelet, and a 2-inch horizontal tear over the ankle. The Kevlar insole remains attached to the blast boot, is intact and appears to be undamaged. The heel portion of the cushion insole has been shredded with the rear 1-½ inches missing.

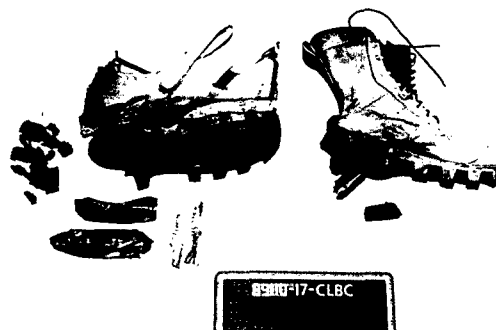
The rear 5 inches of the medial heel and the rear 3 inches of the lateral side of the heel have been removed by the blast. The blast deflector, attenuator, and attenuator plate have been completely separated from the overboot. The rear one-quarter of the blast deflector has been badly flattened and folded with a 3-inch split in the metal down the mid-line. The blast deflector has been bent upward approximately 1 inch at the heel. The attenuator has been completely compressed, shredded and recovered in several long strips. The attenuator plate is bent upward 1 inch at mid-heel. The Kevlar insole remains attached to the overboot, and appears to be undamaged. Its canvas covering is badly shredded from heel to mid-foot. The medial portion of the Kevlar upper has been completely separated from the overboot, and has sustained a 2-inch vertical tear with shredding at a point 3 inches forward of the Achilles seam. The lateral portion of the Kevlar upper has been separated from the sole from heel to the toe, but remains attached, and is apparently undamaged. Both sections were completely separated at the Achilles seam.

The sole of the blast boot has been split down the mid-line from mid-foot to the rear of the heel approximately 6 inches, and peeled upward over the rear of the heel cap. The rear two-thirds of the blast deflector, attenuator, and attenuator plate are protruding through the split in the sole, but remain attached to the blast boot. The rear one-quarter of the blast deflector has been almost completely flattened, bent downward, and protrudes through the split in the sole. Likewise the rear two-thirds of the attenuator have been completely compressed, bent downward and protrudes through the split in the sole, along with the attenuator plate. The lateral side of the leather upper has been separated from the sole for approximately 6 inches from mid-heel toward the toe. The lateral side of the leather upper has also been badly shredded by a 7-inch vertical tear from the sole at mid-foot extending upward to the sixth eyelet. There is a 1-1/2-inch vertical tear in the medial side of the leather upper at mid-foot above the arch. There appears to be some buckling of the material of the Kevlar insole at the mid-point of the heel.

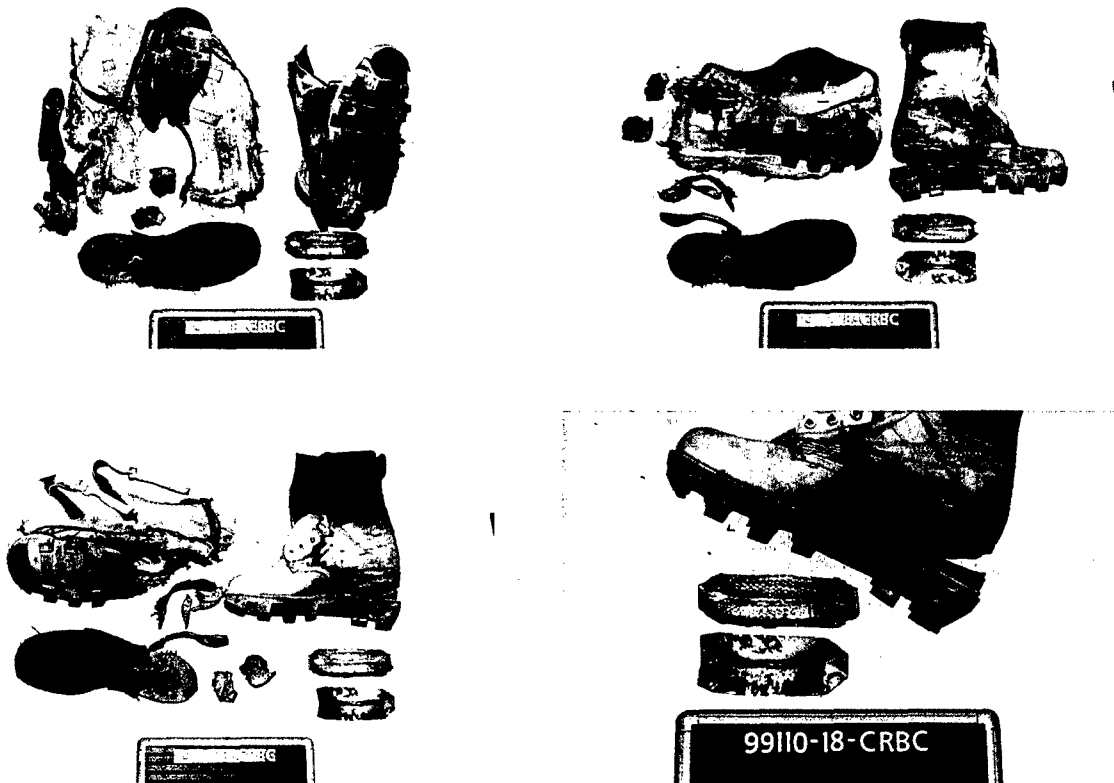
The rear 5 inches of the overboot sole has been completely destroyed by the blast. There are two 2-inch longitudinal tears in the sole at mid-foot. The blast deflector, attenuator, and attenuator plate have been completely separated from the overboot. The blast deflector has been badly flattened and folded at mid-heel, resulting in a 3-inch split in the metal along the mid-line. The rear one-half of the blast deflector has been bent upward approximately 1 inch. The blast deflector was completely separated from the overboot. The attenuator and attenuator plate have been completely separated from the overboot. The rear one-quarter of the attenuator is missing with the remaining portion compressed and badly shredded. The Kevlar insole has been completely separated from the overboot, but is intact and appears to be undamaged. The insole's canvas covering has been torn and shredded from heel to mid-foot. The lateral portion of the Kevlar upper has been completely separated from the overboot by the blast. It has a 3-inch vertical tear with extensive shredding of the Kevlar material over the lateral portion of the heel. The medial portion of the Kevlar upper has been separated from the sole from heel to toe, but remains attached to the overboot at the toe, and does not appear to have sustained any damage to the Kevlar material.

The sole of the blast boot has a 5-inch longitudinal tear down the midline of the heel from the rear of the heel to mid-foot. The blast deflector was completely separated from the blast boot. The blast deflector has been flattened and bent upward approximately 1/4-inch in its center. The attenuator and attenuator plate were completely separated from the blast boot and the attenuator completely compressed. The leather upper has been completely separated from the sole of the blast boot from heel to mid-foot. A 6-inch longitudinal tear along the sole in the heel area, and a 5-inch vertical tear from the arch to the fifth eyelet shredded the medial side of the leather upper. The lateral side of the boot has a 3-inch diagonal tear from the first eyelet to the sole at mid-foot. The Kevlar insole remains attached to the blast boot and appears to have sustained no damage. The cushion insole has a 6-inch longitudinal tear from mid-heel to mid-foot, a 1-inch lateral tear at mid-heel, and a 1-inch lateral tear in the side of the heel.

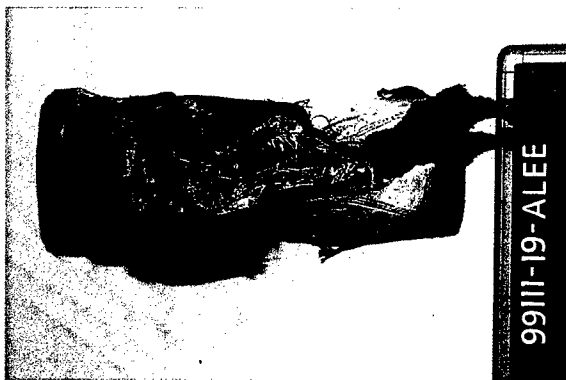
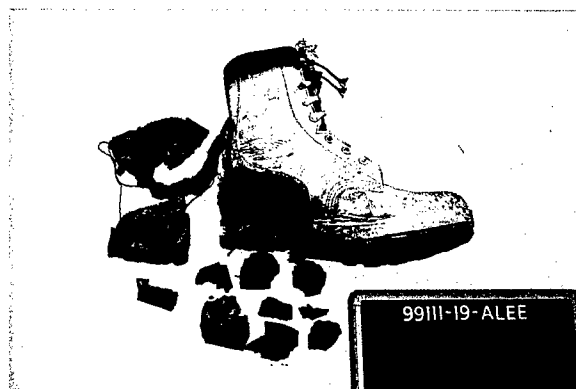
M14 Mine with Singapore manufactured boot.

The rear 4 inches of the heel portion of the sole has been removed by the blast. The Kevlar insole is frayed around the edges and has a 1½-inch lateral tear at mid-heel and a longitudinal tear on the medial side of the heel penetrating the bottom layers of the material. The leather upper remains attached to the Kevlar insole. There is a 3-inch vertical tear in the leather upper, over the medial portion of the heel approximately 3 inches forward of the Achilles seam. A 6-inch vertical tear along the Achilles seam has penetrated the leather upper and the underlying Kevlar liner completely. The leather covering the heel cap portion of the boot has been completely separated from the upper exposing the Achilles seam.

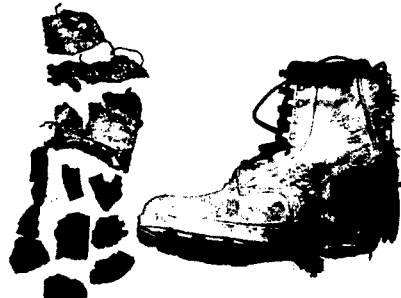
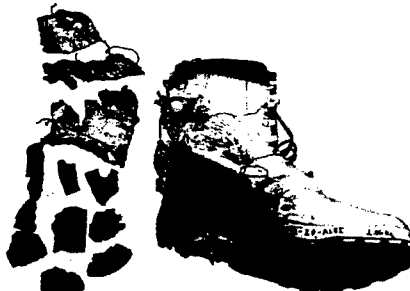
99111-20-ALEE

M-14 Mine with Singapore manufactured boot

The rear 4 inches of the heel portion of the sole has been removed by the blast and recovered in several large pieces. There is a 2-inch longitudinal tear in the lateral side of the sole at mid-foot. The leather upper has been completely separated from the sole and the Kevlar insole throughout the heel area. The leather heel cap portion of the upper has been badly shredded and completely separated from the boot. A vertical tear along the Achilles seam, which penetrates the leather upper and Kevlar lining, has opened the entire back of the boot. There is a 1-inch tear in the Kevlar lining at the rear of the heel.

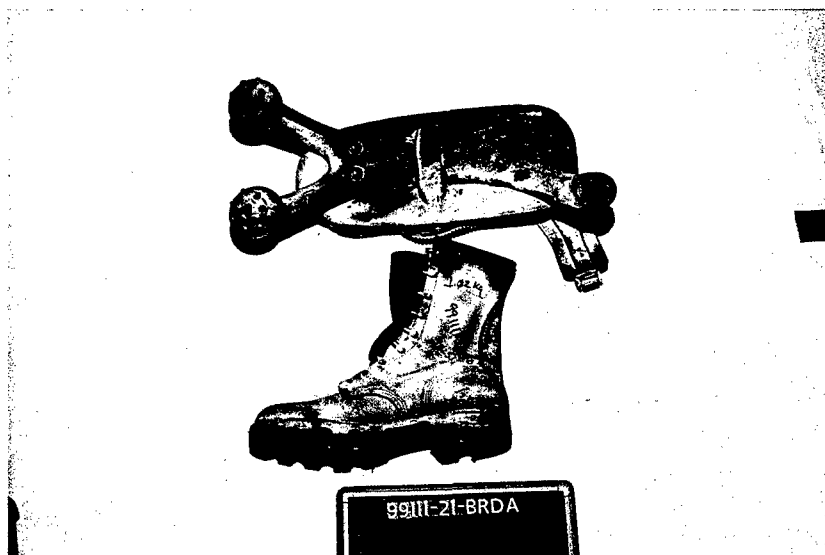
The left rear leg of the Canadian overboot has been removed by the blast. The area of the sole immediately above the left rear leg has received some damage and several cracks are visible. The right rear leg has received some superficial damage and is missing its rubber pod; otherwise, the overboot appears to be intact and undamaged with no damage to the bindings/attachment plate.

The combat boot is intact and appears to be undamaged. Removal of the cushion insole reveals no damage to the leather insole of the combat boot.

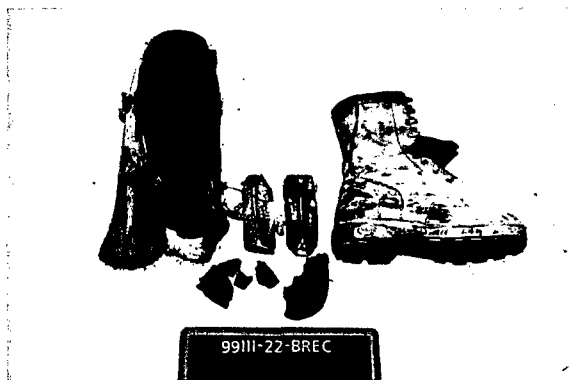
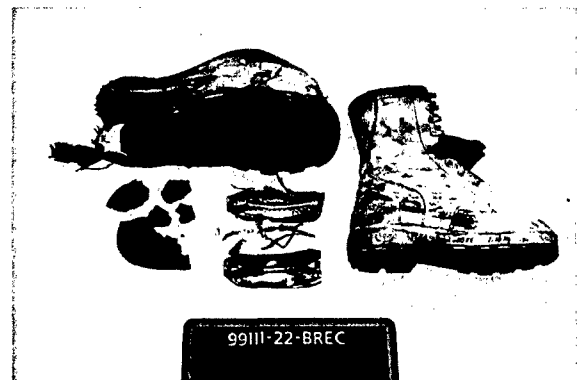
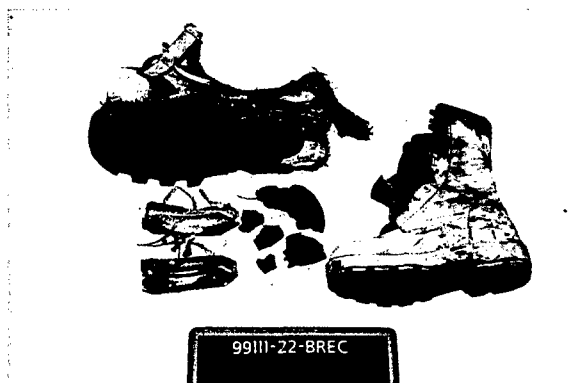
The sole of the Singapore blast boot is apparently undamaged. There is a 1 1/2-inch vertical tear in the black cloth lining inside the boot 1 inch above the insole directly over the Achilles tendon. There are no tears or apparent damage to the leather upper of the boot, however the white paint applied to the boot pre-test has flaked off along wrinkle lines indicating there was some compression of the leather upper.

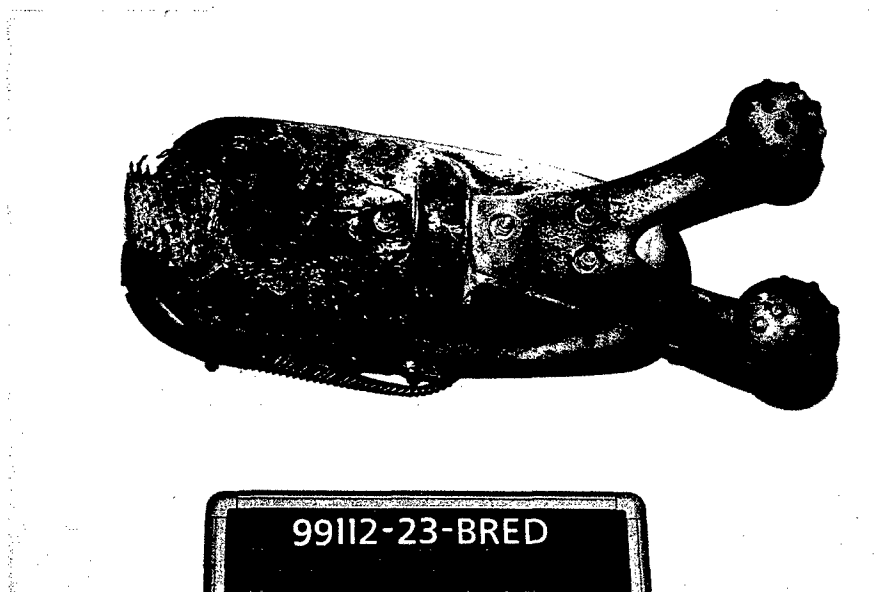
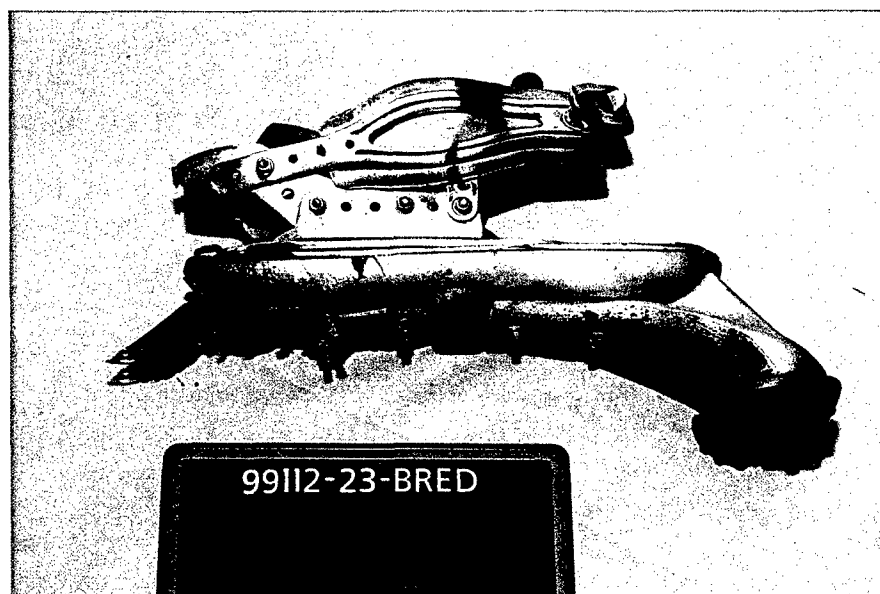
The rear two legs of the Canadian overboot were completely removed by the blast. Fragments of the legs were recovered along with one intact pod and one fragmented pod. A 1½ inch x 2 inch section at the extreme rear portion of the overboot has been destroyed. The screws attaching the rear set of legs to the overboot remain in place. The lateral edge of the insole plate of the overboot has sustained a 7-inch crack in the material from the heel to the mid-foot. There appears to be no damage to the bindings or binding attachment plate.
